SUBJECT: Contract No. DE-AM01-07000LM00060, Stoller  
Task Order LM00-502, LTS&M – Other Defense Activities  
Transmittal of the September 2008 Fernald Preserve On-Site Disposal Facility  
Inspection Forms  
Activity Code OSDF-1225

# FERNALD PRESERVE OSDF WALKDOWN INSPECTION FORM

# On-Site Disposal Facility Inspection Report

## September 2008

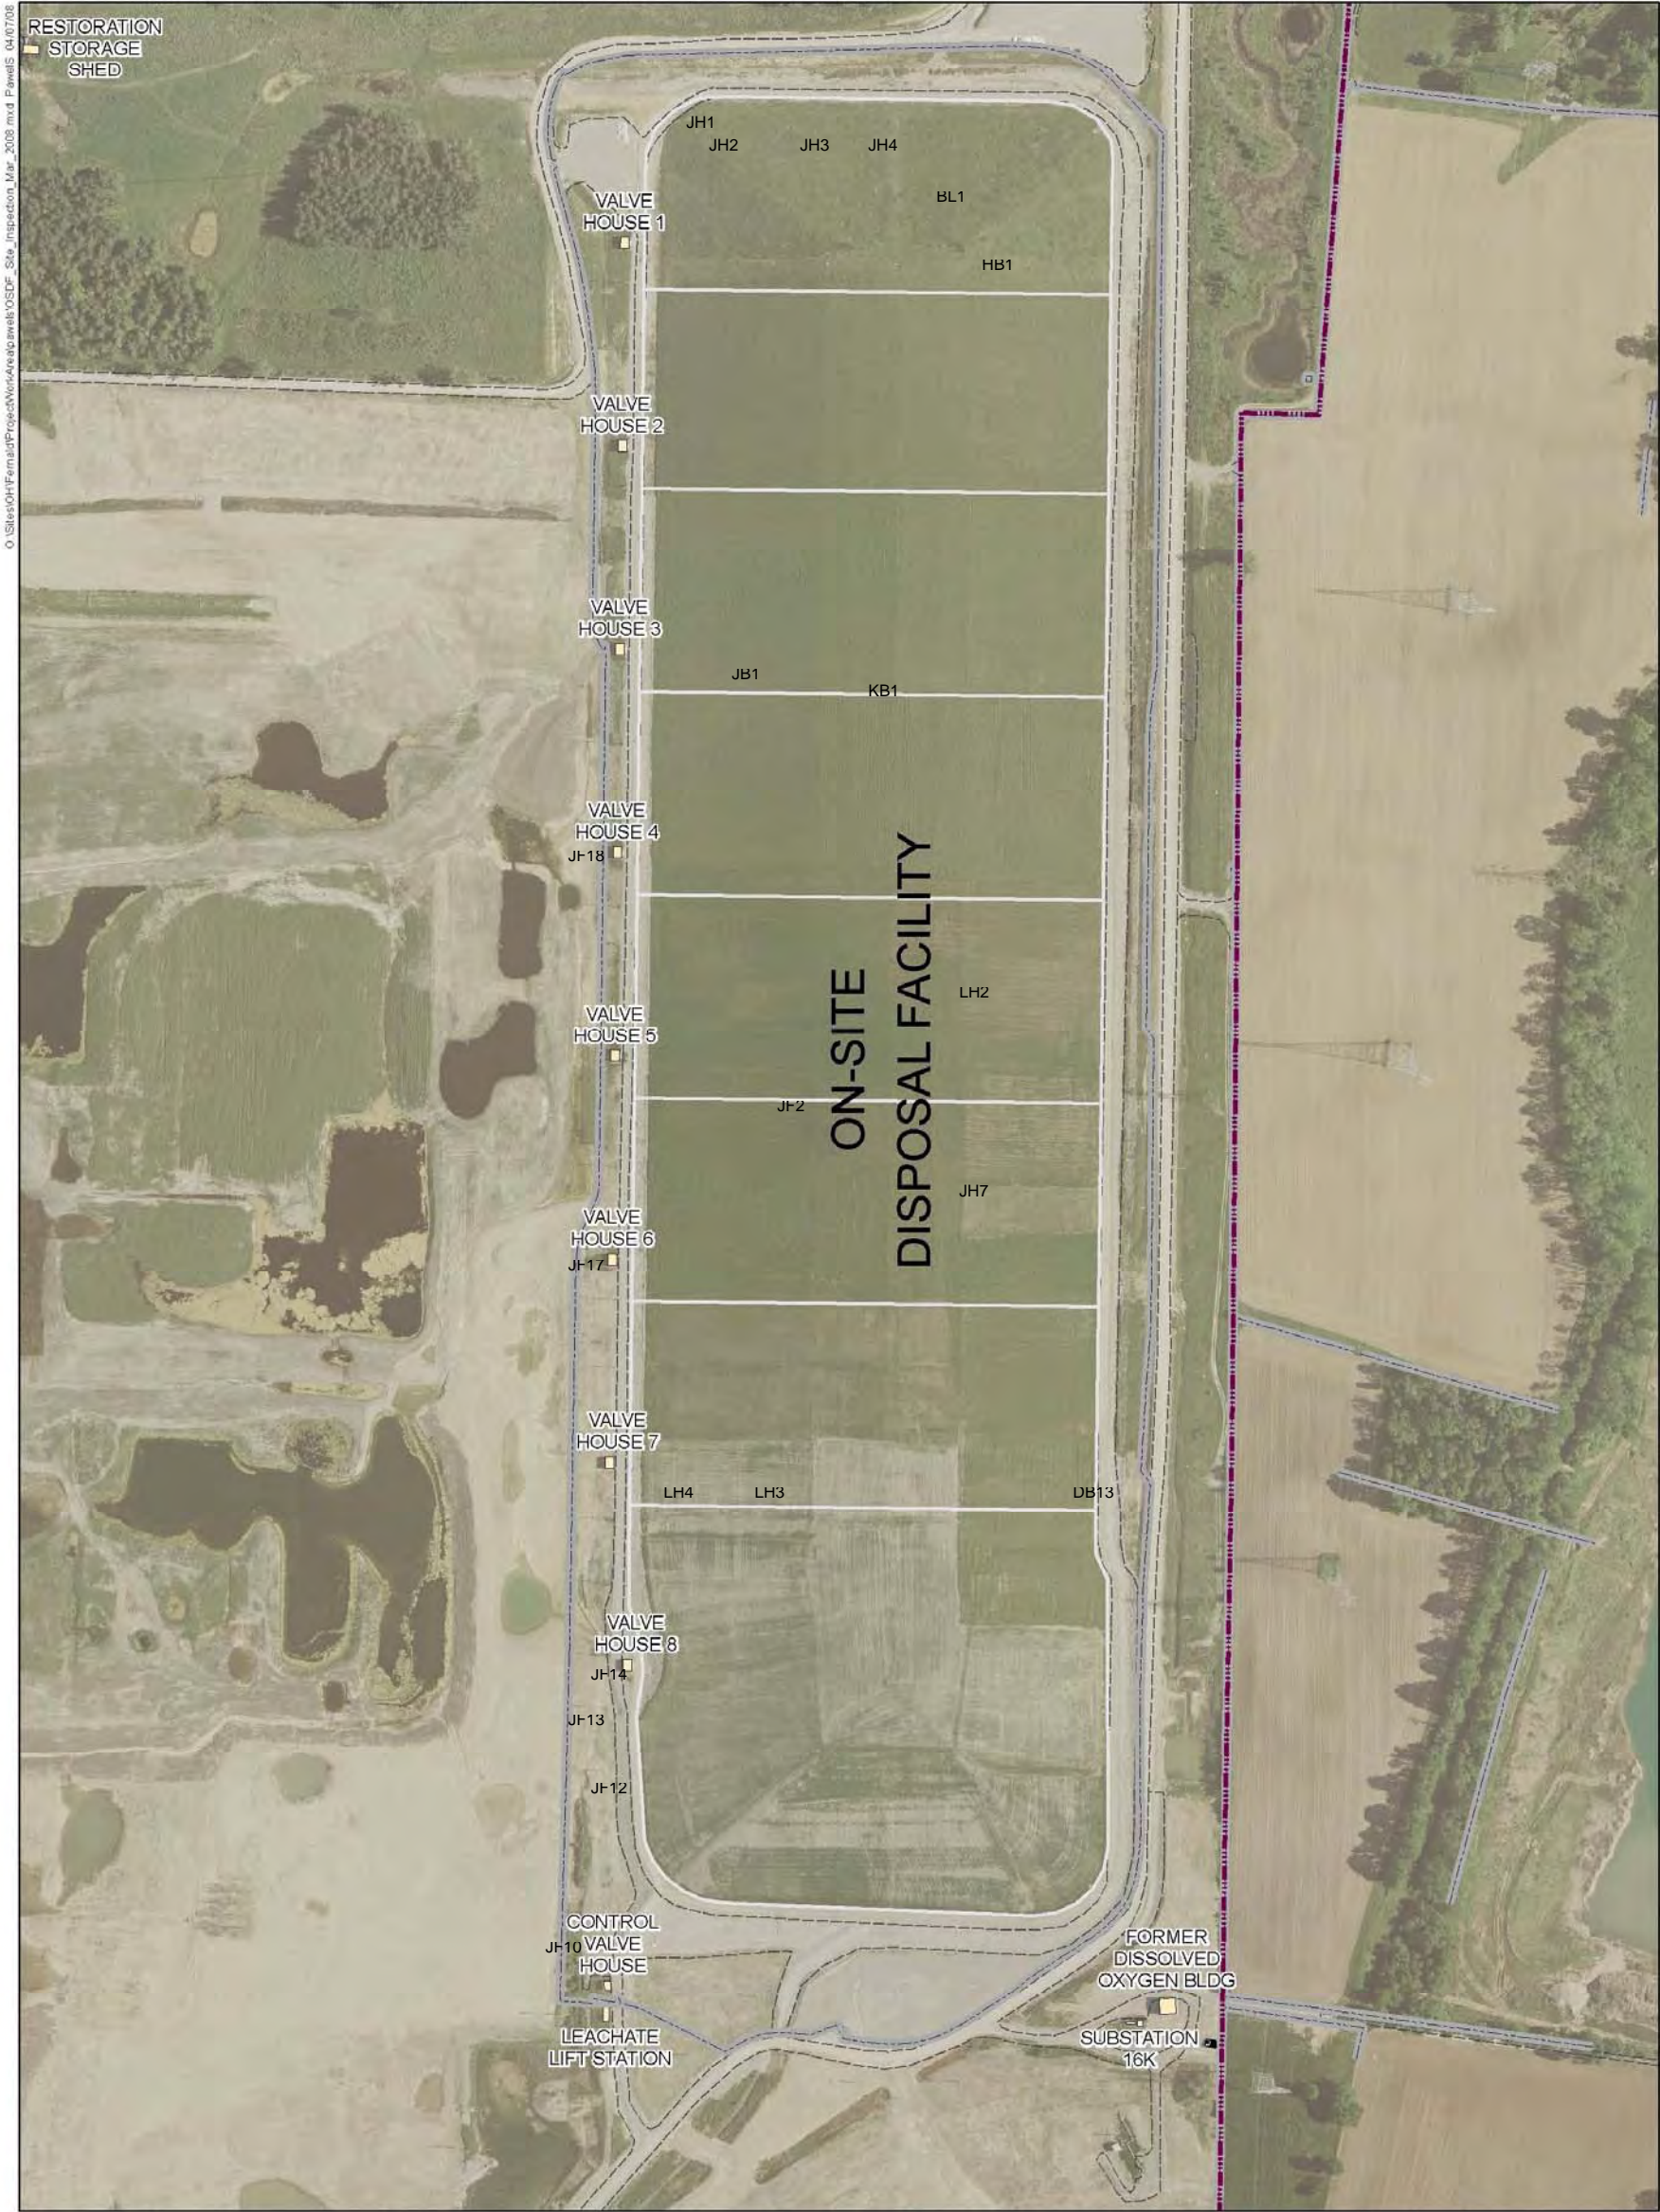
**Fernald Preserve  
OSDF (On-Site Disposal Facility)  
September 2008 Inspection Findings**

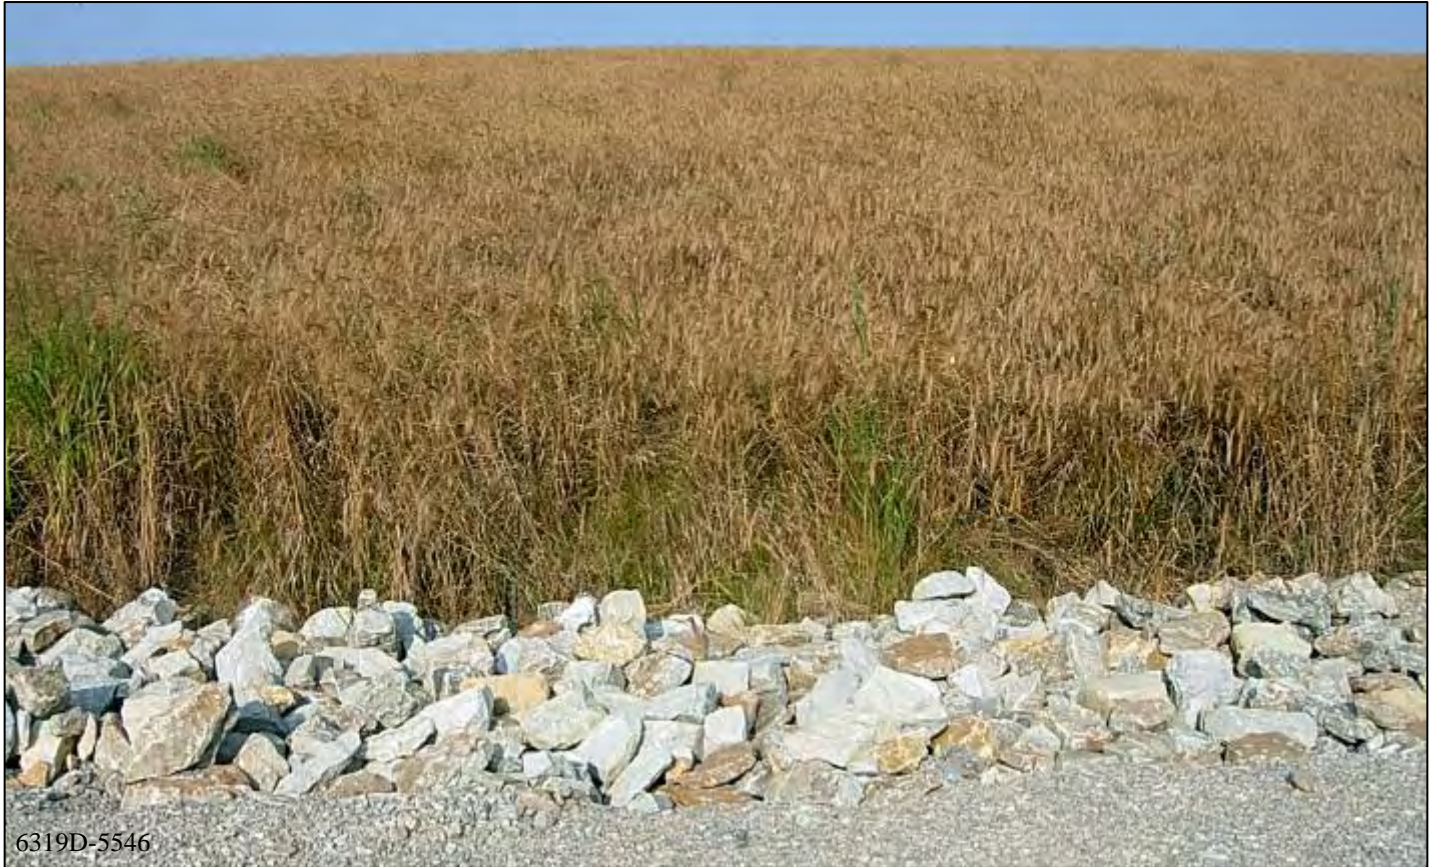
**East Face Cell 3**

The results of the Cell Cap 3 monitoring were positive. Cover was over 90 percent for all quadrats sampled. In addition, both percent native species and relative frequency of native species were calculated above 50 percent. While the vegetative cover of Cell Cap 3 does not represent the diversity of species originally seeded on the cap, it nevertheless consists of a dense stand of native warm season grasses and forbs. For comparison, 2007 Cell Cap 2 findings showed that while total cover was over 90 percent, native species composition was less than 50 percent. No data was collected on Cell Cap 2 in 2008. However, it appears through casual observation that the native mix of species has increased, and is now more consistent with the 2008 Cell Cap 3 findings (see attached photographs of Cell 2 and Cell 3).

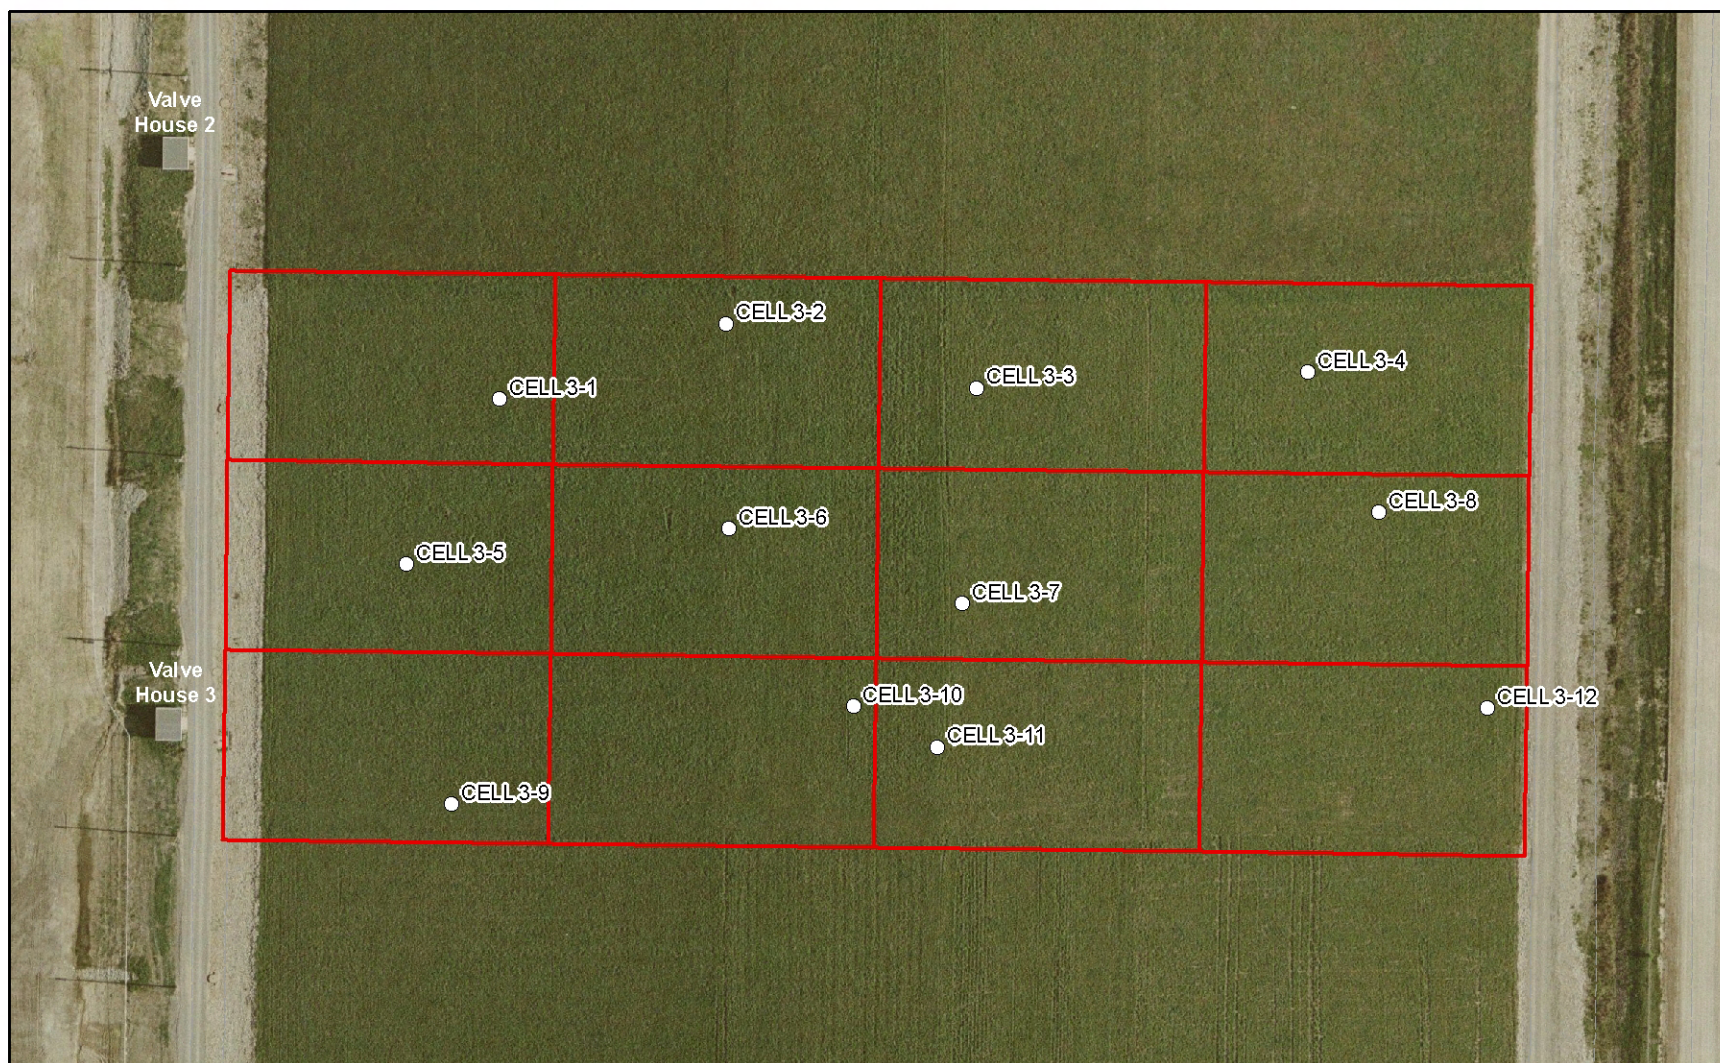
OSDF Cell Cap 3 Herbaceous Sample Grid

Pursuant to Volume II of the LMICP, herbaceous cover data was collected for Cell Cap 3. One one-meter square quadrat was randomly located within each of 12 grid locations across the Cell 3 Cap. The attached figure shows the location for each of these sampling locations. Within each quadrat, total cover and species richness data were collected. From this information, native species composition and relative frequency of native species was calculated. The attached table presents a summary of the Cell Cap 3 data.
